BRUHAT BANGALORE MAHANAGARA PALIKE
INSPECTION REPORT

ANNEXURE 2- INSPECTION REPORT - OBSERVATIONS

Name of the Work: Construction of RCC drain at Maramma Temple main road in Amruthahalli in Ward No. 07 K.S.D (Sl. NO. 18)					
Sl No	Item	Measurements and Qty as per Claims (MB & Bills)	Measurements and Qty as per Actuals	Deviation	% Deviation
1	Length of drain	800m	800m	nil	nil
2	Depth of drains	600mm	600mm	nil	nil
3	No. of culverts (Deck Slab)	2	2	nil	nil

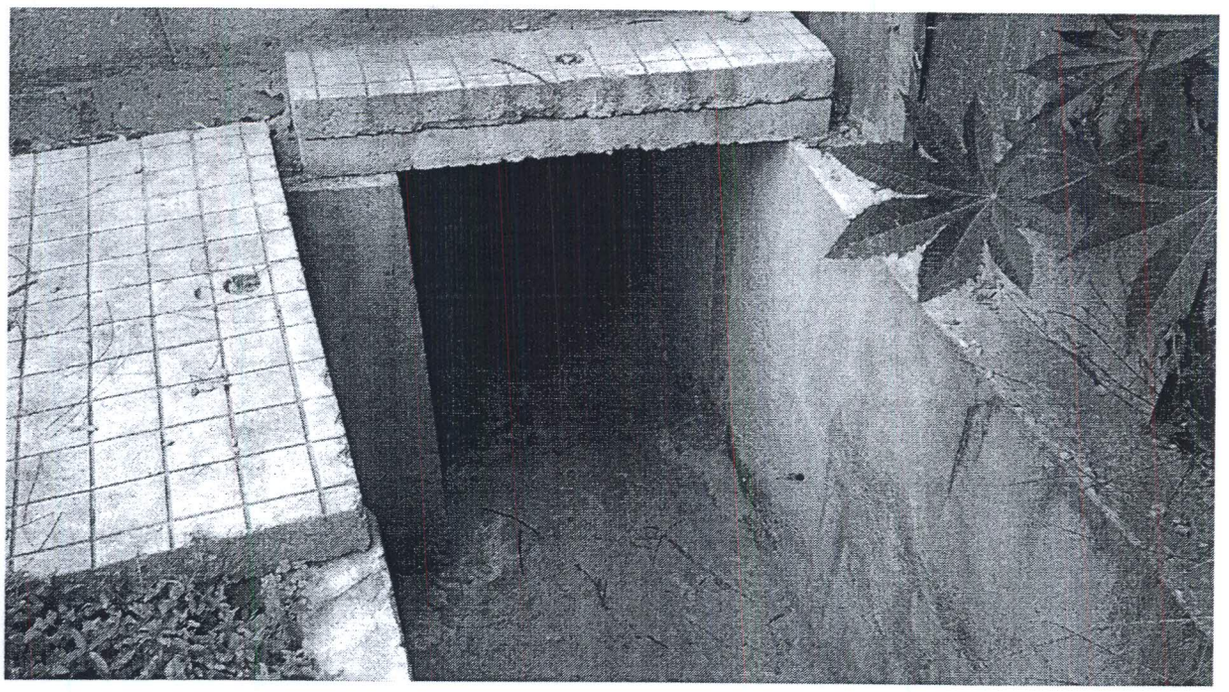
Construction of RCC drain at Maramma Temple main road in Amruthahalli in Ward No. 07 K.S.D (Sl. No. 18) - Satisfactory
